Biofilter Treatment System at the East Kingston Septage Facility

*Final Project Report
of Water Quality Monitoring
1996 and 1997*

Bodwell Farm, East Kingston, NH

NHDES-R-WD-01-2

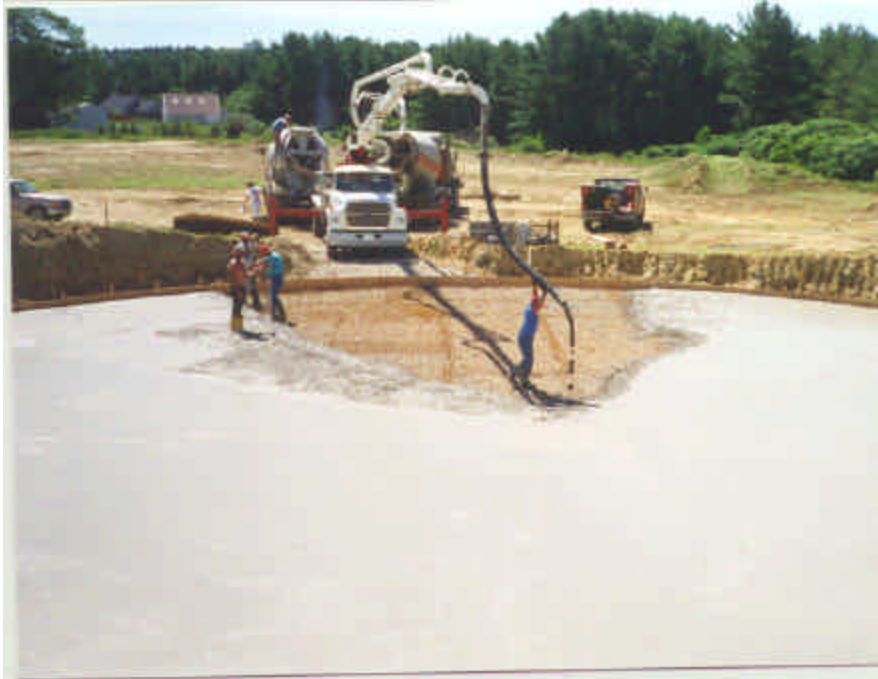
Pouring concrete onto the base of the silo

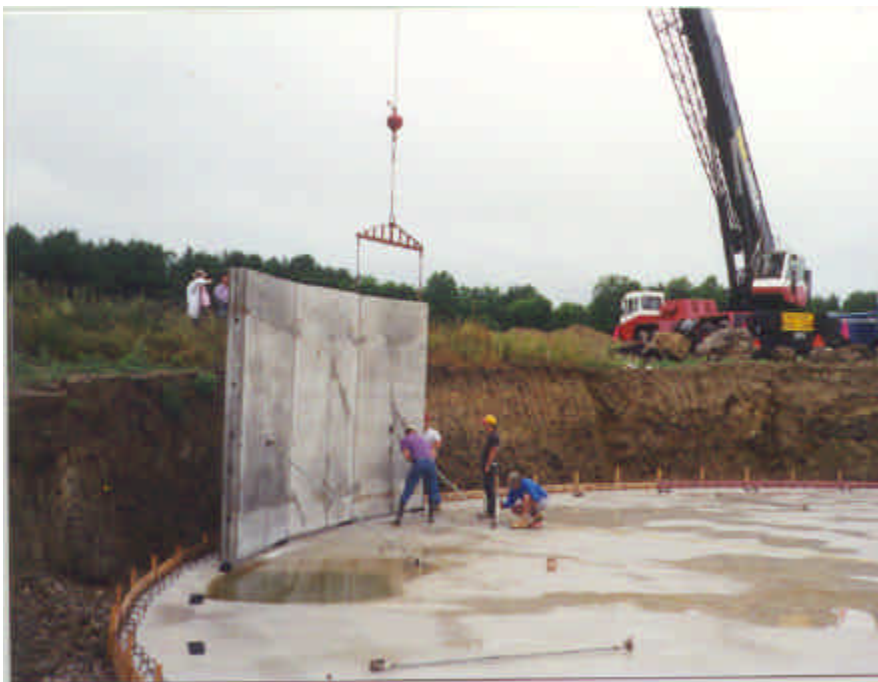
Installing silo walls

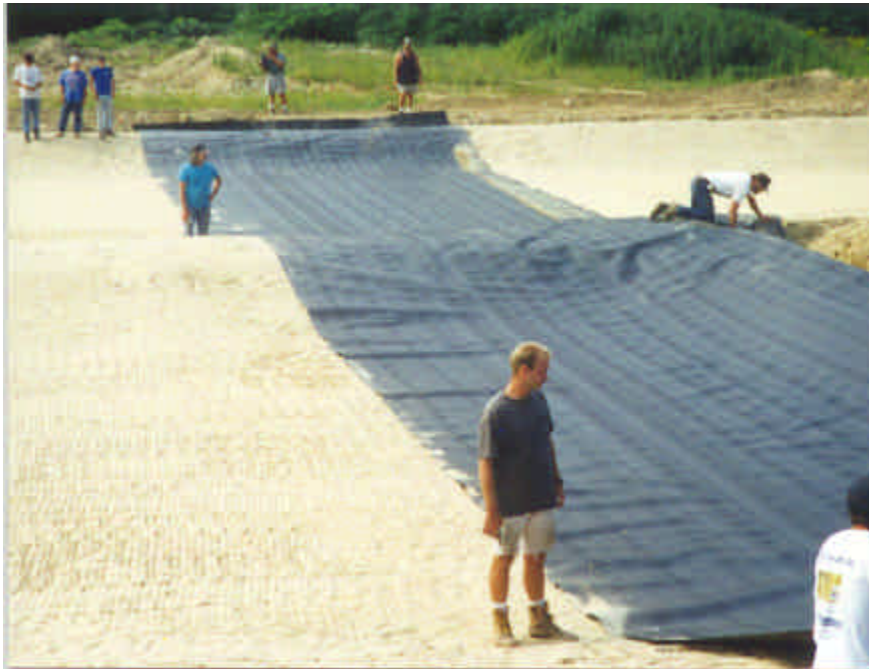
Laying down liner for wetland cells

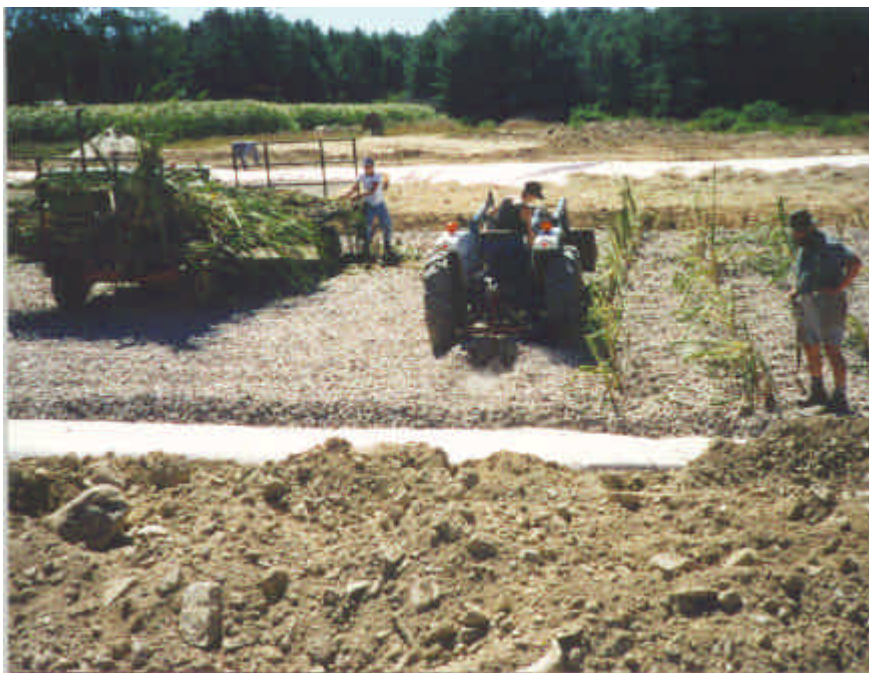
Installing wetland vegetation

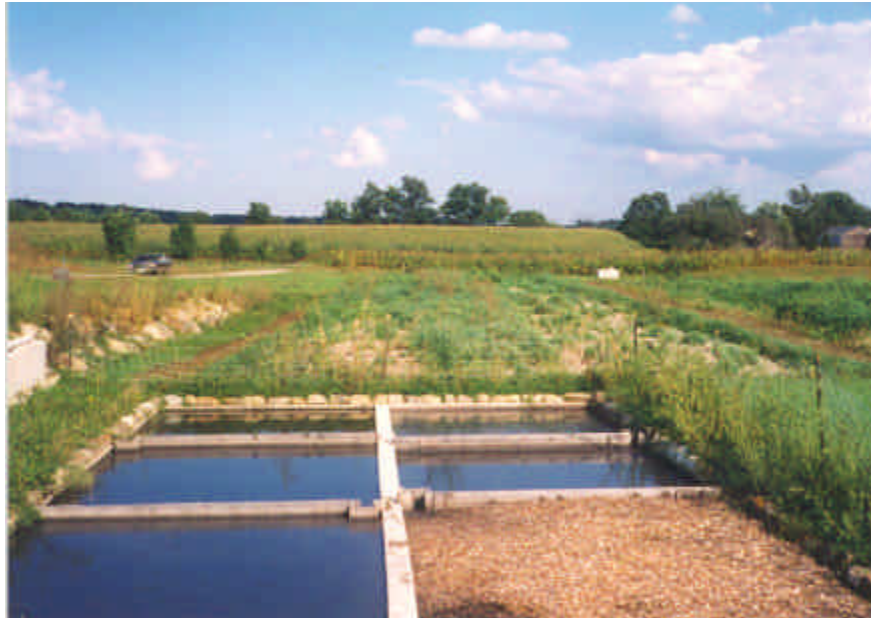
Pretreatment chambers in foreground; wetland cells in background

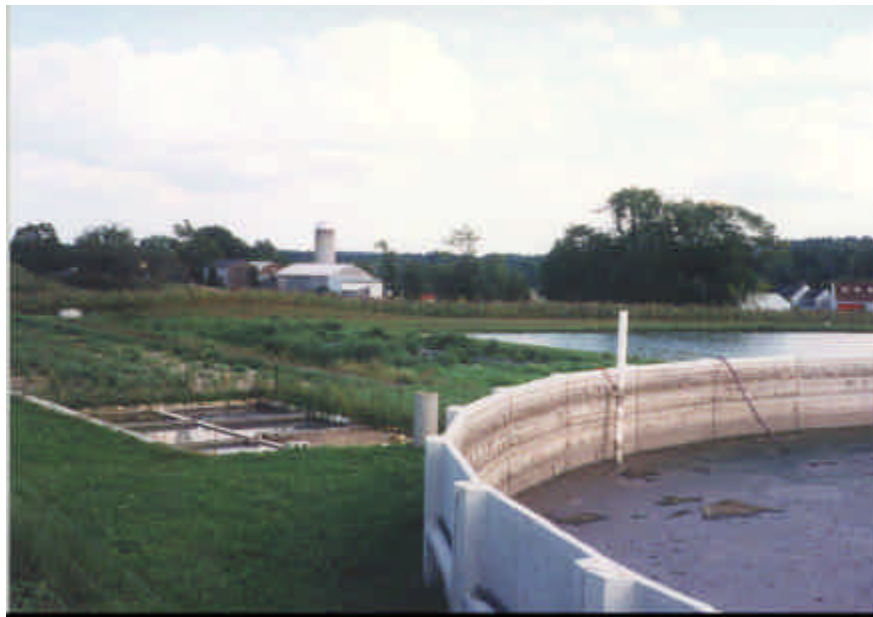
View of facility; receiving meadow and pond in background
